**GEOTECHNICAL FEASIBILITY STUDY  
TIMBERLINE VILLAGE  
Auburn, California**

File No. NRS-6028-01  
June 2, 1993

Subject: Timberline Village  
Auburn, Placer County, California  
**GEOTECHNICAL FEASIBILITY STUDY**

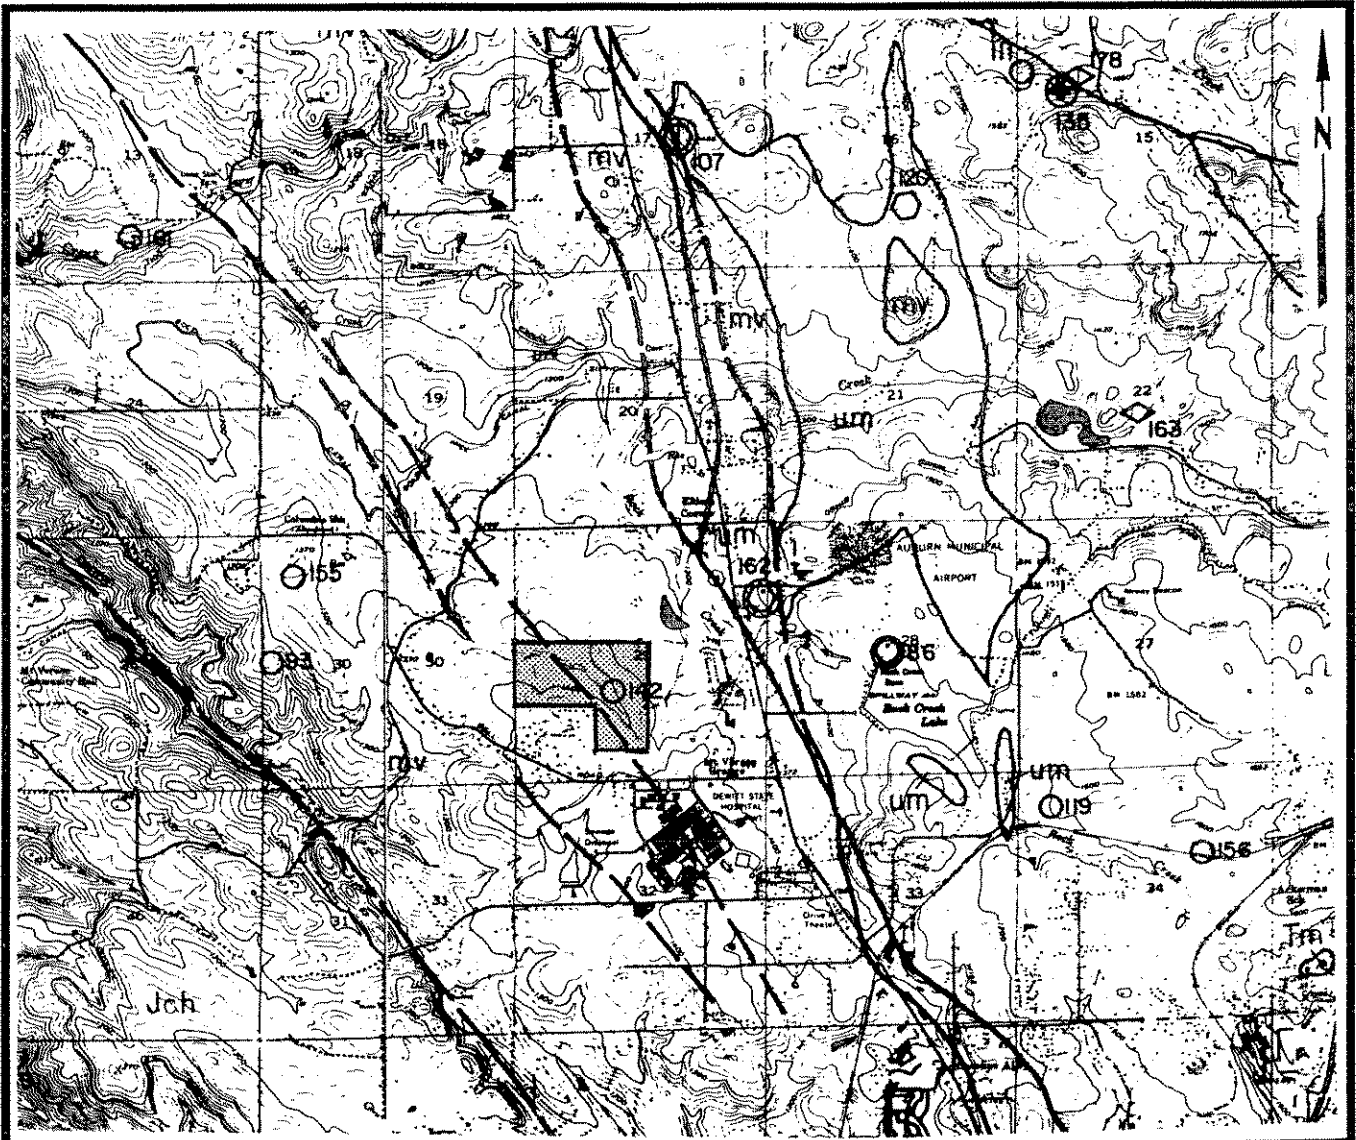
FIGURE 3

-Base from C.D.M.G., 1984, Open File Report 83-37

The regional geology has been mapped by the California Division of Mines and Geology (Mineral Land Classification of Auburn 15-minute Quadrangle, 1984; Geologic Map of the Sacramento Quadrangle, 1987). These maps differ in scale but agree that the site is underlain by metavolcanic melange terrane rock of Paleozoic-Metazoic age. That part of the California Division of Mines and Geology (1984) map that includes the site is shown in Figure 3. The underlying unit (mv) is described as metavolcanic rocks within a belt of chaotically intermixed rocks.

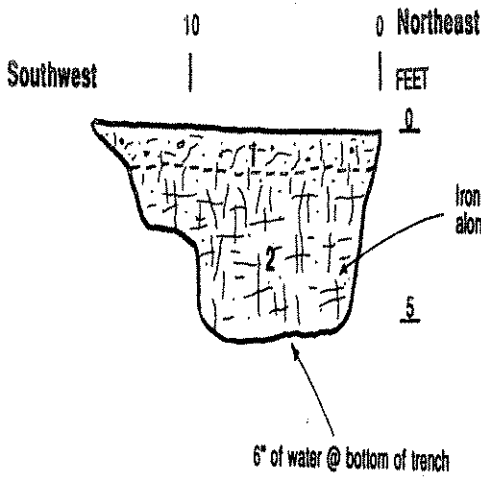
**TEST PIT 1**  
N9°E NW Face

**UNIT DESCRIPTIONS TEST PIT 1**

- 1. Clayey silty/silty clay with sand and gravel  
7.5YR 3/2 Dark brown, moist, wet at contact with unit 2, firm, slightly porous to porous, sand and gravel size fragments are composed of subangular metamorphosed volcanics and subrounded milky quartz.
- 2. Metamorphosed volcanics  
Grey to olive, moist where weathered, hard, slightly porous, fractured, slightly friable, has a greenish aphanitic groundmass and very fine-grained anhedral crystals within groundmass.

Nine test pits were excavated on the site on March 26, 1993, with the use of a rubber-tired backhoe. The test pits ranged in depth from 4 to 6 feet. The excavations were logged by a staff geologist and representative samples were taken of the units encountered. In addition to bulk samples, relatively undisturbed samples were obtained by manually driving a 3.0-inch O.D. sampler (containing a 2-1/2-inch diameter, 6-inch long liner) with a slide hammer. Those samples were then sealed and taken to our laboratory for subsequent testing and classification. The logs of the excavations, showing the geologic structure and description of the materials encountered, are presented in Appendix A. The locations of the test pits are shown on Figure 2.

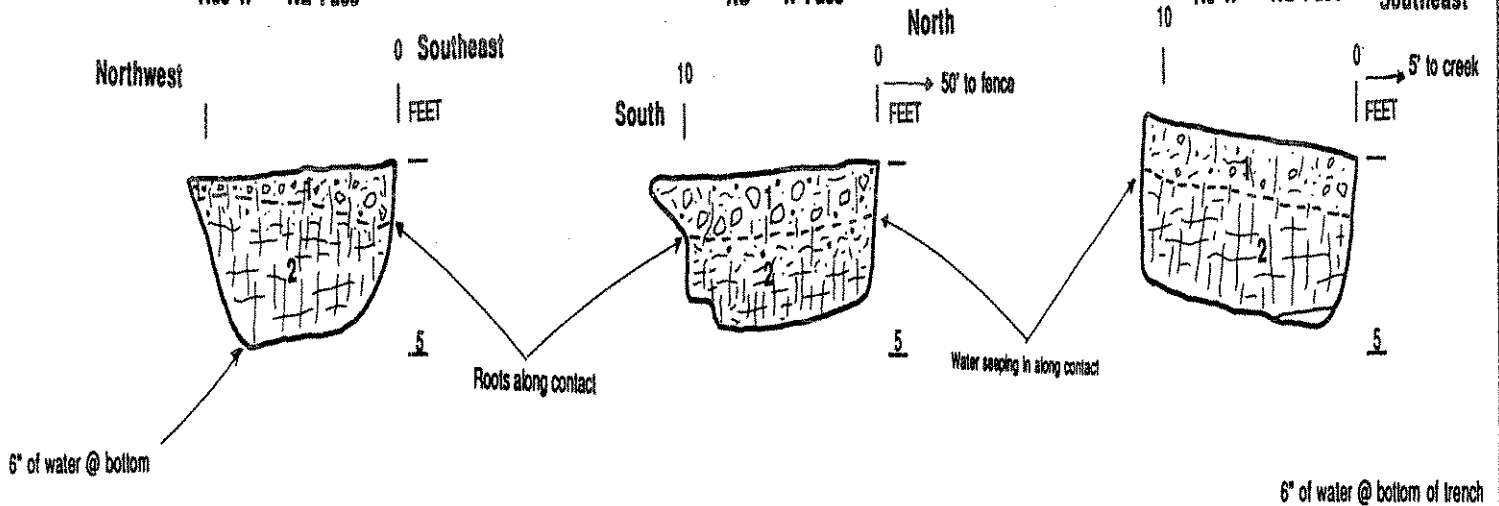
**LOG OF TEST PITS 4, 5 AND 6**  
**Timberline Village**  
**Placer County, California**

**TEST PIT 5**  
NS W Face

**TEST PIT 6**  
N5°W NE Face

| <p>1. Clayey silt/silty clay with sand and gravel size frags</p> <p>2. chlorite schist</p> | <p>7.5YR 3/2 Dark brown, moist, stiff, slightly porous, sand and gravel size fragments are made up of metamorphosed volcanics</p> <p>olive, damp, hard, very slightly porous to non-porous, platy, weakly foliated, semischistose, phaneritic, rocky, blocky, fractured.</p> |

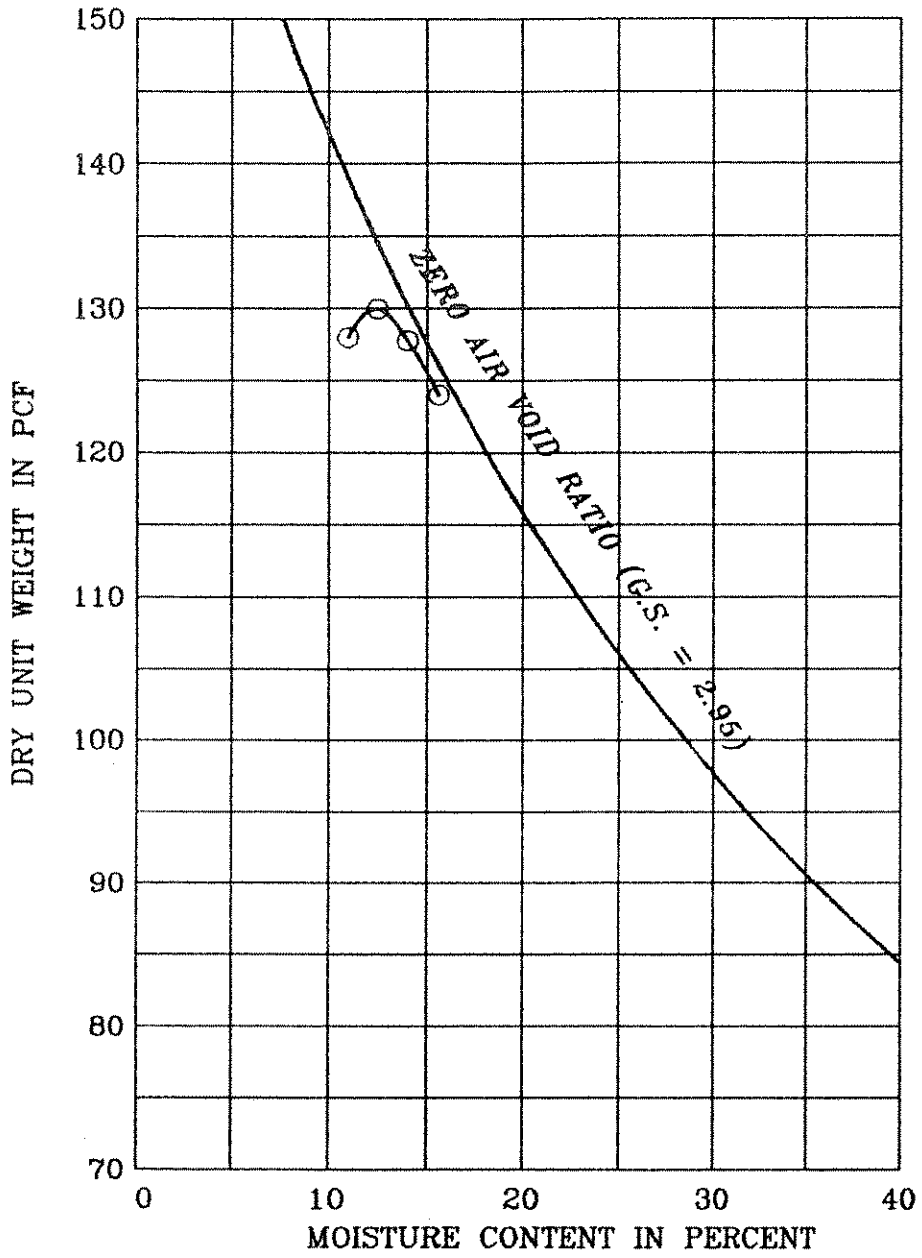
NRS-6028-01	Timberline Village
Earth Systems	COMPACTION TEST

SYMBOL	SAMPLE LOCATION	DEPTH (ft)	DESCRIPTION	TEST METHOD	OPTIMUM MOISTURE (%)	MAXIMUM DRY DENSITY (pcf)
O	B	1.5-6	Tan Sandy Clay	1557-91A	12.5	130.0

Moisture content and density tests were performed on the undisturbed samples in order to determine the in-place density and moisture content variation through the soil profiles. Maximum density, based on the ASTM D1557-91 test method, was determined for a selected representative soil sample from a proposed cut area.

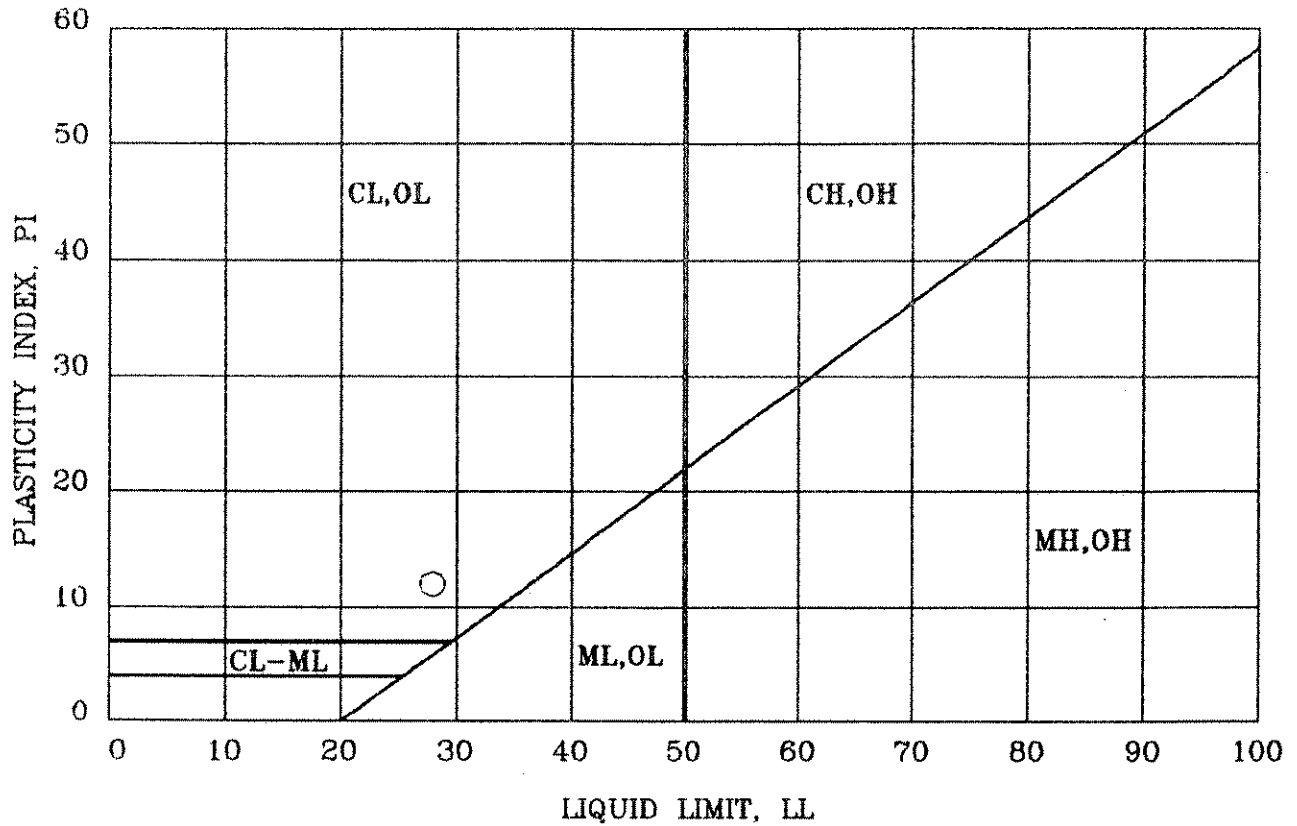
Timberline Village	NRS-6028-01
Earth Systems	PLASTICITY CHART

SYMBOL	BORING	DEPTH (ft)	MC (%)	LL (%)	PL (%)	PI (%)	LI (-)	DESCRIPTION
○	TP-5	1	.0	28	16	12	-1.38	Red. Brn Sandy Lean clay W/ Gvl

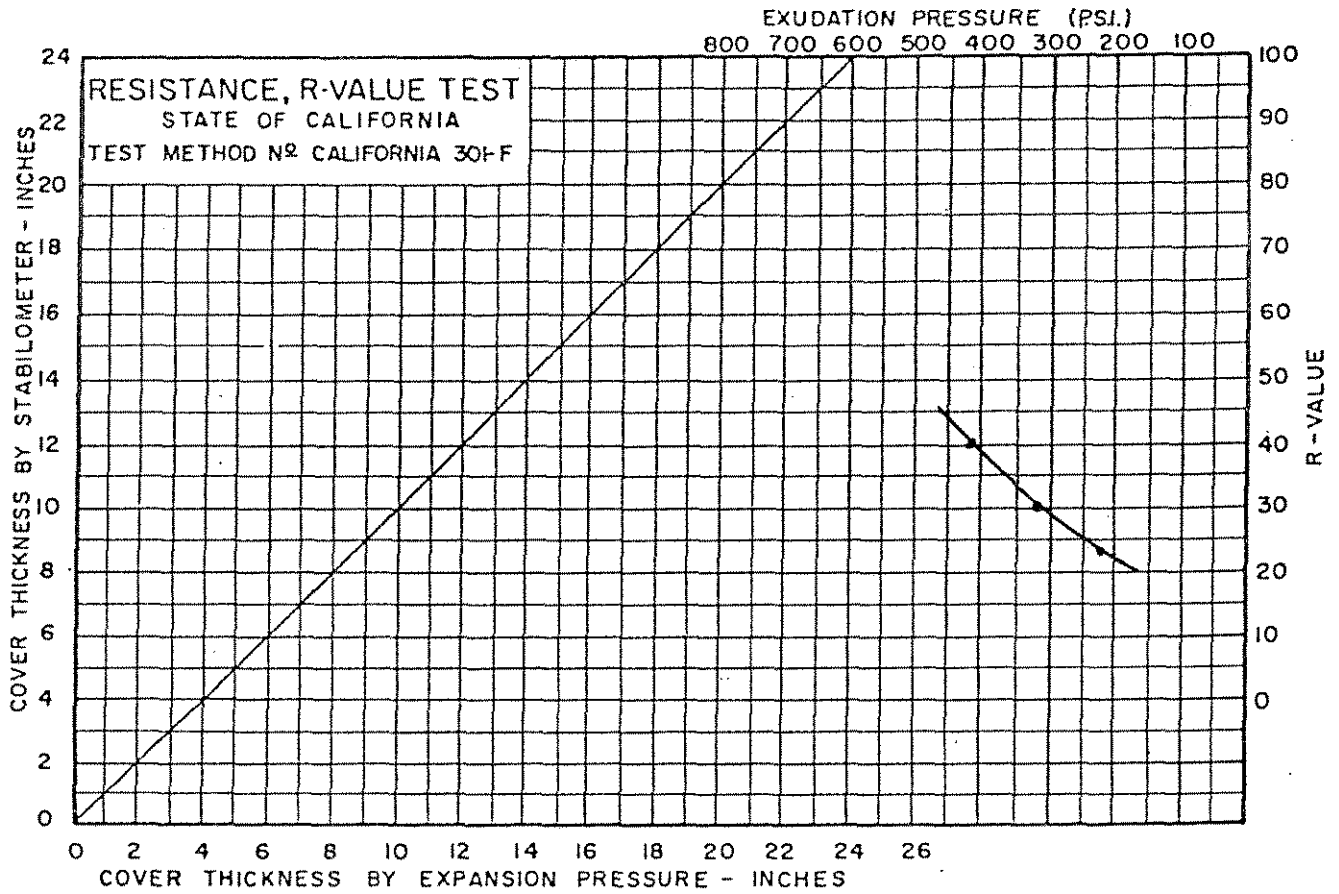
SAMPLE: Bag C (Test pit 5 at 1-foot)  
DESCRIPTION: Reddish brown sandy clay

SPECIMEN	A	B	C
EXUDATION PRESSURE (PSI.)	218	320	420
EXPANSION DIAL (.0001")	20	28	40
EXPANSION PRESSURE (P.S.F.)	87	121	173
RESISTANCE VALUE, "R"	23	30	40
% MOISTURE AT TEST	18.3	17.7	17.0
DRY DENSITY AT TEST (PCF)	112.0	113.6	115.0
"R" VALUE AT 300 P.S.I. EXUDATION PRESSURE	= ( 28 )
